## WALL TO WALL INSPECTIONS.

**FILE #:** 08220401.  
**DATE OF INSPECTION:** 08/22/04.  
**TIME OF INSPECTION:** 530p.  
**CLIENT NAME:** John Smith.  
**MAILING ADDRESS:** 123 E. Main St.  
**CLIENT CITY/ STATE/ZIP:** Colo. Spgs., CO 80900.  
**CLIENT FAX #:**  
**INSPECTION SITE:** same.  
**INSPECTION SITE CITY/STATE/ ZIP:** , same.  
**INSPECTION SITE PHONE #:** same.

## Sample Report

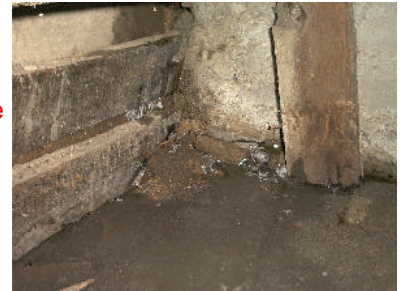
### CRAWL SPACE:

Water is penetrating to crawl space. We recommend the following- A licensed and insured contractor should be called to make further evaluation and repairs as needed. (See also notes on negative drainage)

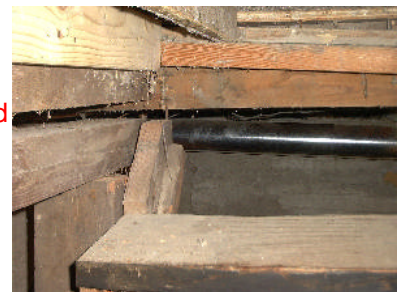
### FRAMING:

Stairs to crawl space are damaged, unsafe conditions now exist. We recommend the following- A licensed and insured contractor should be called to make further evaluation and repairs as needed.

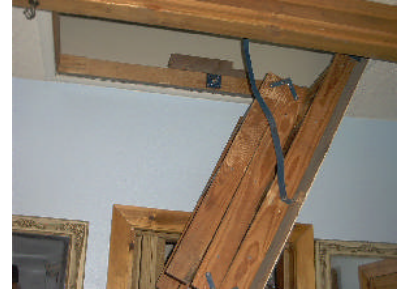
**ROOF  
STRUCTURE &  
ATTIC:**

Roof appears serviceable, Attic stairs are broken, Components are significantly deficient, due to unsafe conditions which now exist. We recommend the following- A licensed and insured contractor should be called to make further evaluation and repairs as needed.

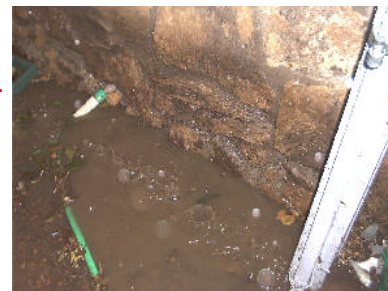
#### GRADING:

We recommend the following- A licensed and insured contractor should be called to make further evaluation and repairs as needed. Neg. grading in back and along east side.

Improper sloping is causing water to penetrate into crawl space. We recommend the following- A licensed and insured contractor should be called to make further evaluation and repairs as needed.

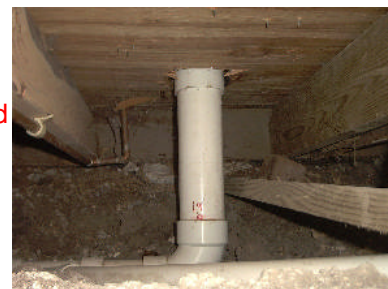
**Main toilet is inadequately vented and has negative drainage. We recommend the following- A licensed and insured contractor should be called to make further evaluation and repairs as needed.**

Toilet does not flush properly. Probably due to negative flow and improper venting.

A licensed and insured contractor should be called to make further evaluation and repairs as needed.

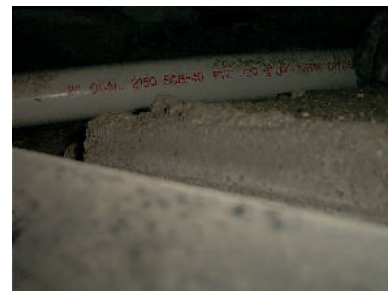
**Kitchen drainage has negative drain flow. We recommend the following- A licensed and insured contractor should be called to make further evaluation and repairs as needed.**
